SOME AREAS OF LANDSLIDE ACTIVITY IN VICTORIA, AUSTRALIA

By E. B. JOYCE* and R. S. EVANS*†

ABSTRACT: Four areas of landslide activity have been studied in Victoria, and these demonstrate the types of landslide which occur on two susceptible local rock types, Early Cretaceous arkose and mudstone, and Tertiary clay-rich sediments.

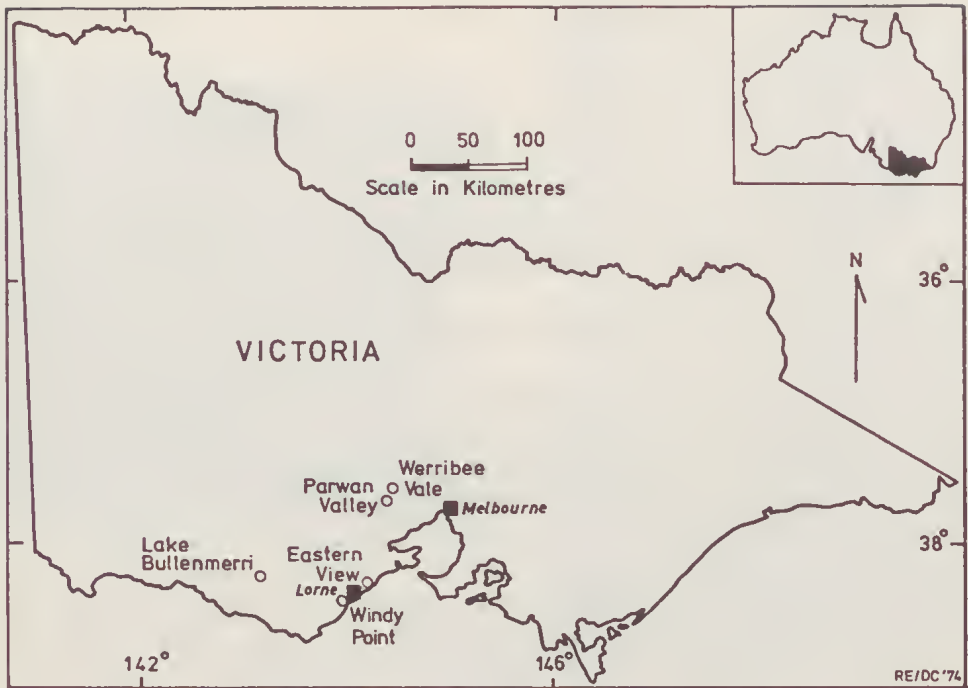
FIG. 1—Location of areas studied.

The four areas studied are shown in Fig. 1. A general review of landslides in Victoria showing all known areas has been published elsewhere (Evans & Joyce 1974).

Windy Point is 3.2 km south of Lorne, on the Great Ocean Road (Fig. 1 and 2) and was the location of a large rock slide from 1968 until late 1971, when the slide was stabilized by cable anchoring. Windy Point is a minor headland of massive, strongly-jointed Early Cretaceous arkose, with minor thin mudstone beds which have largely decomposed to a silty clay (Pl. 16A). Two near-vertical prominent joint sets at roughly 90° to each other are present, but statistically

At Eastern View, 110 km south-west of Melbourne (Fig. 1) a slope shows a number of mass movement features which are not present at the forested Windy Point area. The slope was cleared near the end of the last century, and numerous failures have taken place, both on the main north-east-facing slope which has a stream below, and on the steep slope facing the ocean and the Great Ocean Road.

The Parwan Valley and Werribee Vale area is near Bacchus Marsh, which is approximately 50 km west-north-west of Melbourne (Fig. 1). It represents two of the worst sites of mass movement and other types of erosion to be found in Victoria. Particularly in the Parwan Valley gully erosion, piping and sheet erosion are the main

Lake Bullenmerri is a lake in a volcanic crater near Camperdown, nearly 200 km west-south-west of Melbourne (Fig. 1). The crater was formed by a late Quaternary eruption of maar type, and is part of the Newer Volcanic province of south-eastern Australia (Ollier & Joyce 1973). Since the slopes were cleared of vegetation around the turn of the century (E. D. Gill, pers. comm.) the upper part of the north-west crater wall has been degrading by land slipping. A complete spectrum of different types of shallow landslide is present (Fig. 10).

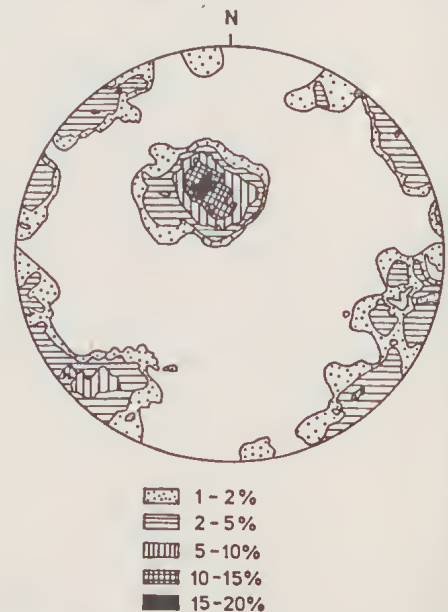
FIG. 6—Equal area projection of planar discontinuities (bedding and jointing) at Windy Point. 102 points.

there is a large range in individual values. The bedding strikes at 74° east from true north and dips at 27° south-cast. An equal area projection of planar discontinuities for Windy Point shows the statistical dominance of the bedding (Fig. 6).
